FirstEnergy Nuclear Operating Company

Subject: Supplemental Information regarding License Amendment Application to Revise
Technical Specification 3/4.4.5, "Reactor Coolant System - Steam Generators," to
Permit One-Time Extension of Steam Generator Tube Inservice Inspection Interval
(TAC No. MC1573)

SUPPLEMENTAL INFORMATION REGARDING LICENSE AMENDMENT
APPLICATION TO REVISE TECHNICAL SPECIFICATION 3/4.4.5,
"REACTOR COOLANT SYSTEM - STEAM GENERATORS," TO PERMIT
ONE-TIME EXTENSION OF STEAM GENERATOR TUBE INSERVICE
INSPECTION INTERVAL

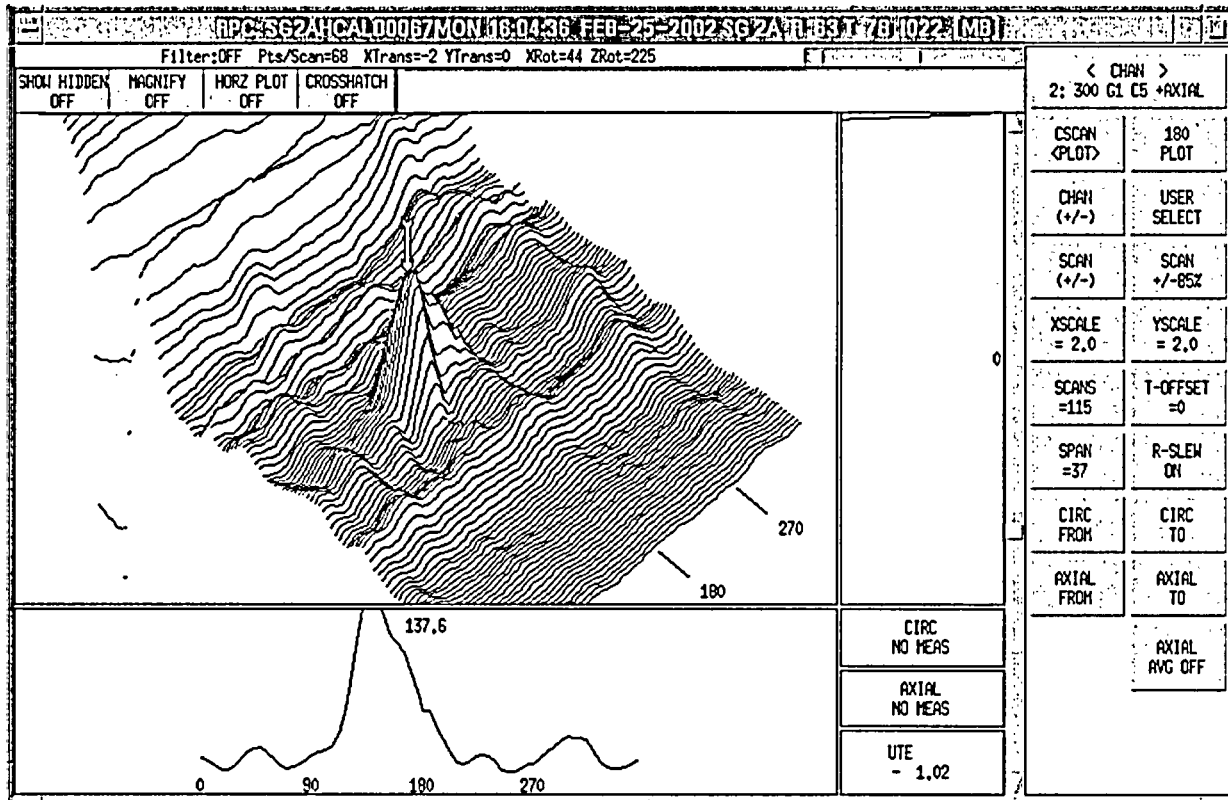
Figure 1 – C-scan of R63T78 in 13RFO

During inservice inspection of the Davis-Besse Nuclear Power Station (DBNPS) once-through steam generators (OTSGs) during the thirteenth refueling outage (13RFO), an axial crack was identified in OTSG tube 2A-Row 63 Tube 78. The axial crack in OTSG tube 2A-Row 63 Tube 78 was in the roll expanded region of the tube, in the upper roll, but not in the roll transition region itself. This particular crack is not characteristic (length, depth, voltage) of what has historically been observed in once-through steam generators at the roll transition area. Roll transition cracking in the OTSGs is typically <1 volt Plus-point, confined within the transition (<0.25"), and with average depths much less than 90% through-wall (TW). Because of its location within the roll joint and above the transition, this indication had no impact on the DBNPS structural or leakage integrity at end-of-cycle (EOC).¹³ Figure 1 provides the Plus-point C-scan plot of this indication/region. The thirteenth refueling outage (13RFO) inspection was the first inspection of this tube in this region after 15.8 effective full power years (EFPY) of operation at DBNPS with an eddy current technique that is capable of reliably detecting indications of this degradation type/location. The fact that the profile of the indication is >90%TW for almost its entire length is not totally unexpected (Figure 2). Upper 95th percentile growth rates for these indications in OTSGs is approximately 13%TW/EFPY and 0.2"/EFPY, indicating approximately 4-5 cycles of growth for this particular indication. The bobbin coil data for this tube was also reviewed from both the 13RFO and 12RFO inspections and indicated the presence of a signal that can be matched to that of the Single Axial Indication (SAI) reported in 13RFO from the Plus-point inspection (Figures 3 and 4). This data also indicates that the growth did not occur over a single cycle and is consistent with the historical growth rates of this degradation.

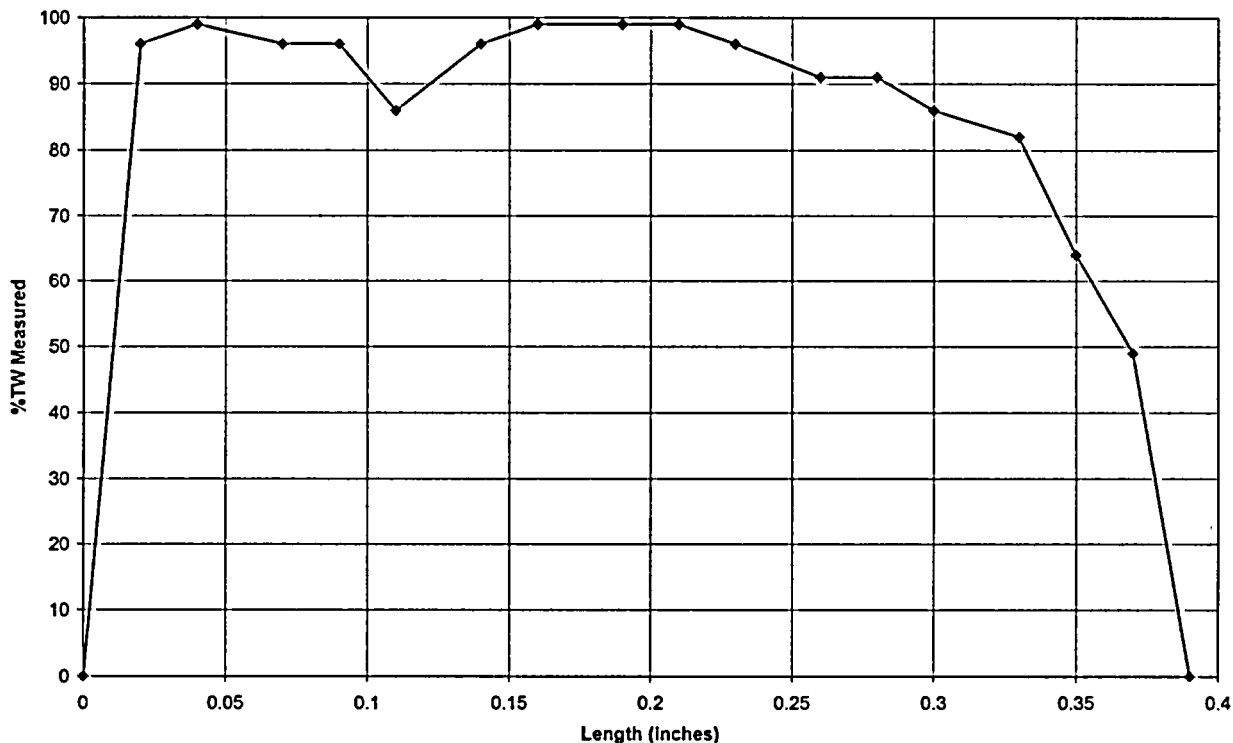
Figure 2 – NDE Profile of R63T78

Profile of SAI in Tube 2A-63-78
